Our 1800S - For Love, Not Money (Part I).

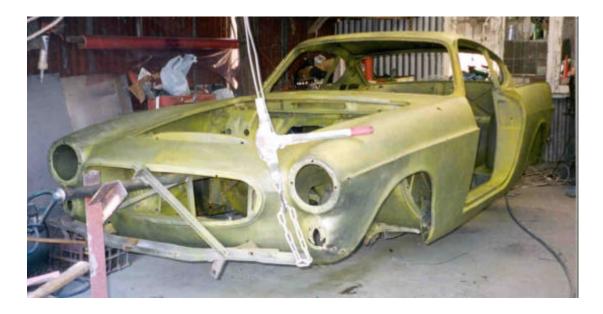
First was the chemical strip. It left a truly naked shell and a startling view of the holes left by the now killed rust. In addition it uncovered previous other body repairs: a deep gouge to the right rear quarter panel, a substantial impact to the rear and a previous rust repair to the LH door sill. I had become aware of this when I had great difficulty removing the rear wiring loom which passes through this sill - the sill had been re-welded with the wiring loom still inside! The outer sheath and insulation had been melted into a block of plastic in the middle of the sill, yet surprisingly everything in the rear end still worked!

With the body fully stripped, I was not happy leaving the untidy looking repairs to the LH chassis rail. Once the repairs had been ground off, intuition to remove it proved correct as forward of the cross member was merely very fine Swiss cheese.

Having gone this far, there was only one way forward. Every hint of rust was cut out. Replacement panels were purchased where available (guard sections, sills, wheel arches, rear ¼ panels & indicator inserts) otherwise hand beaten. Panel beating the boot proved one of the more time consuming tasks it was so out of shape.
