Gen 0.5 Smiths Tachometer Module Analysis

Mark Olson, Alex Miller, 2024

Starting in model year 1960 into early 1964, Smiths Instruments made the model RV1310/nn tachometers for Volvo P1800 cars.. The electronics of all of the nn versions are the same. Volvo later recommended that the Gen 0.5 tachometers be replaced with Gen 1 units. In this document, we analyze the electronics in the Gen 0.5 Smiths RV1310/nn tachometers.

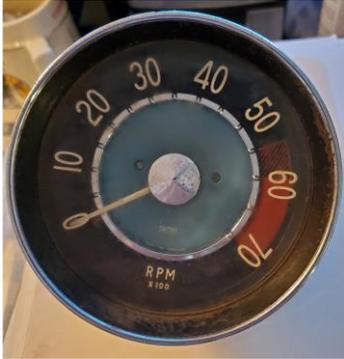
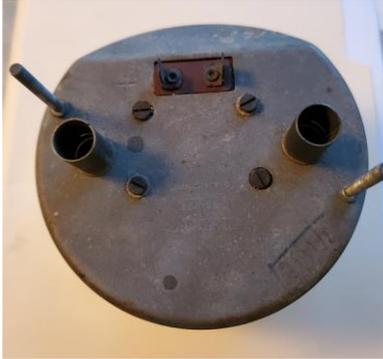
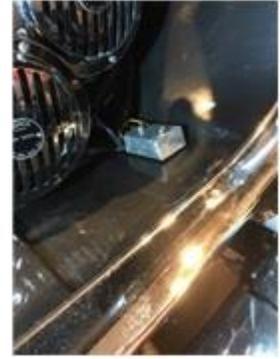
The head unit is a simple ammeter calibrated in RPMs. Note that one terminal is marked with a "+". The other terminal is not marked but is for ground. The electronics are contained in a potted module mounted in front of the radiator.

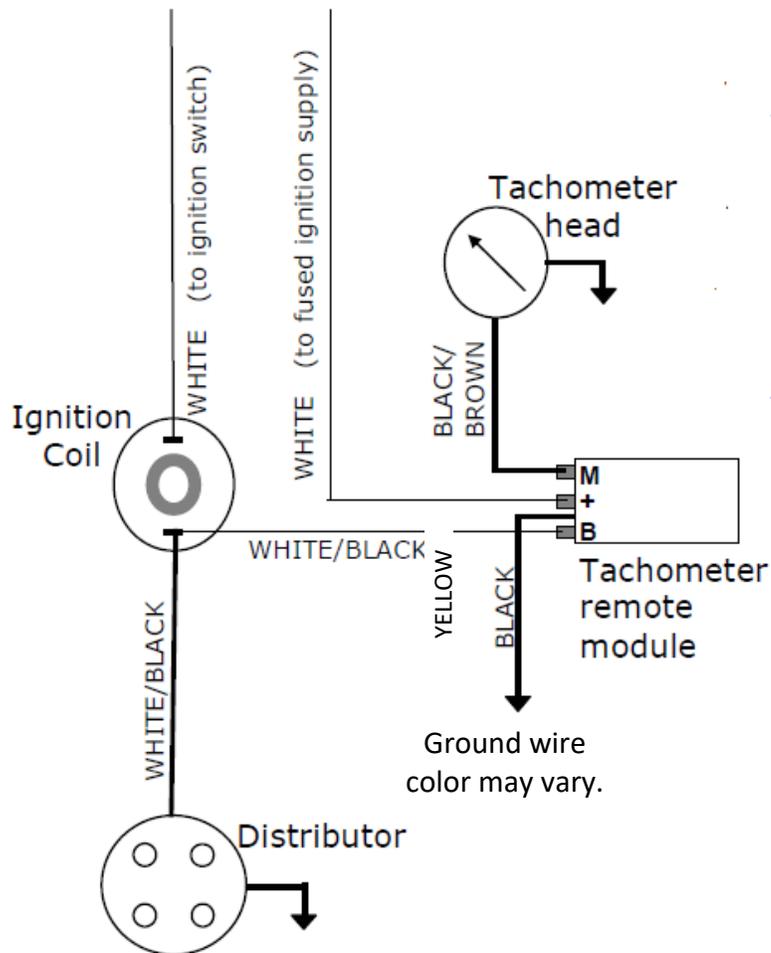
The negative terminal of the head unit is grounded and the positive terminal is connected to the "M" terminal of the module. The "+" terminal is connected to switched battery voltage. The "B" terminal is connected to the coil negative terminal and the yellow or black wire is grounded to one of the module bolts.

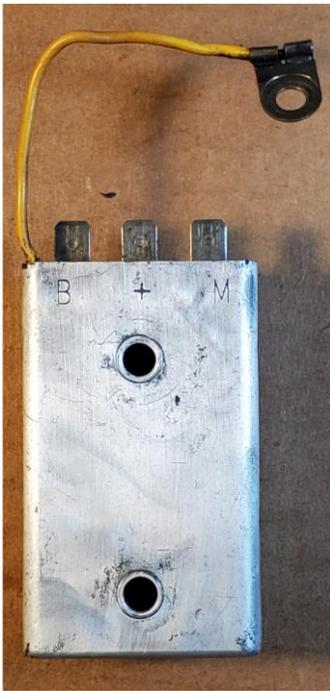
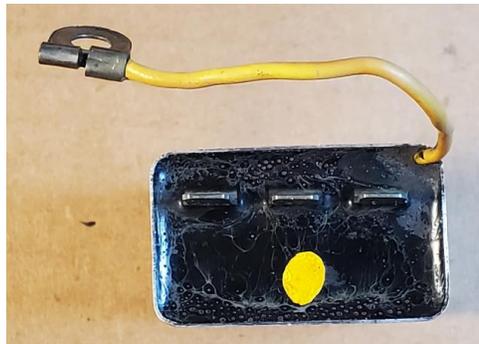
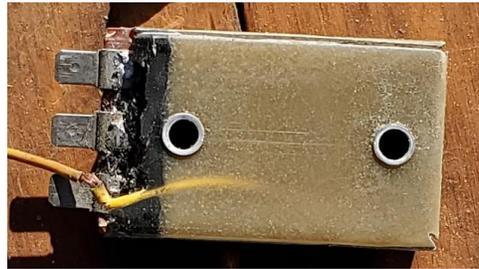
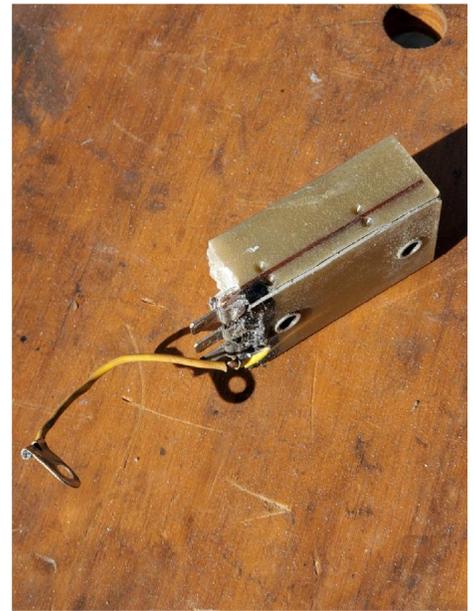
The rest of this document will describe what we were able to determine about the circuit inside of the remote module. The PCB assembly is potted in a can using some sort of potting compound which I will call epoxy in this document. The PCB assembly was first slid between the 4 dimples on each side of the can. The mounting sleeves were fitted and light epoxy was poured in to about 1/4" from the top of the can. After that, the remaining space in the can was filled with black epoxy. The purpose of the yellow dot is unknown.

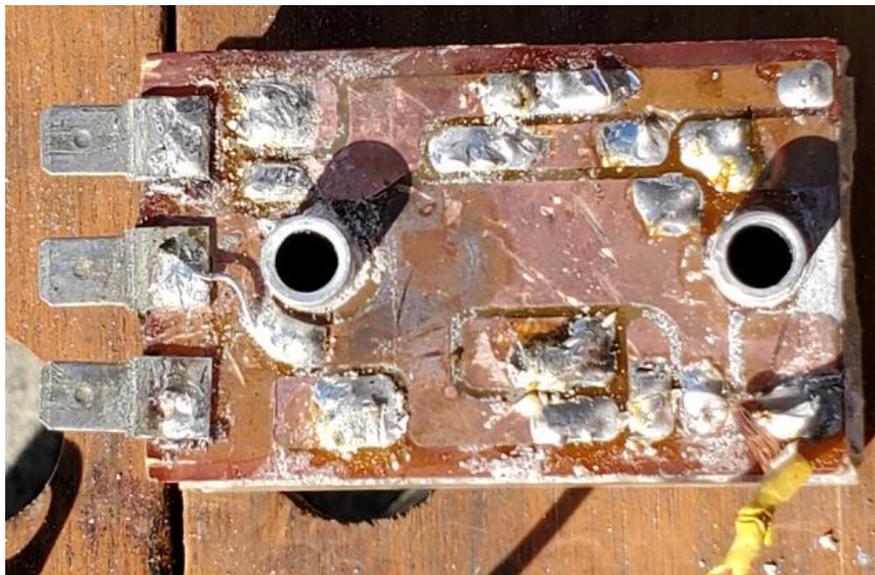
I initially used a heat gun to heat up the epoxy which made it easier to chip away the epoxy. I started with the bottom side of the PCB which was pretty easy to get clean.

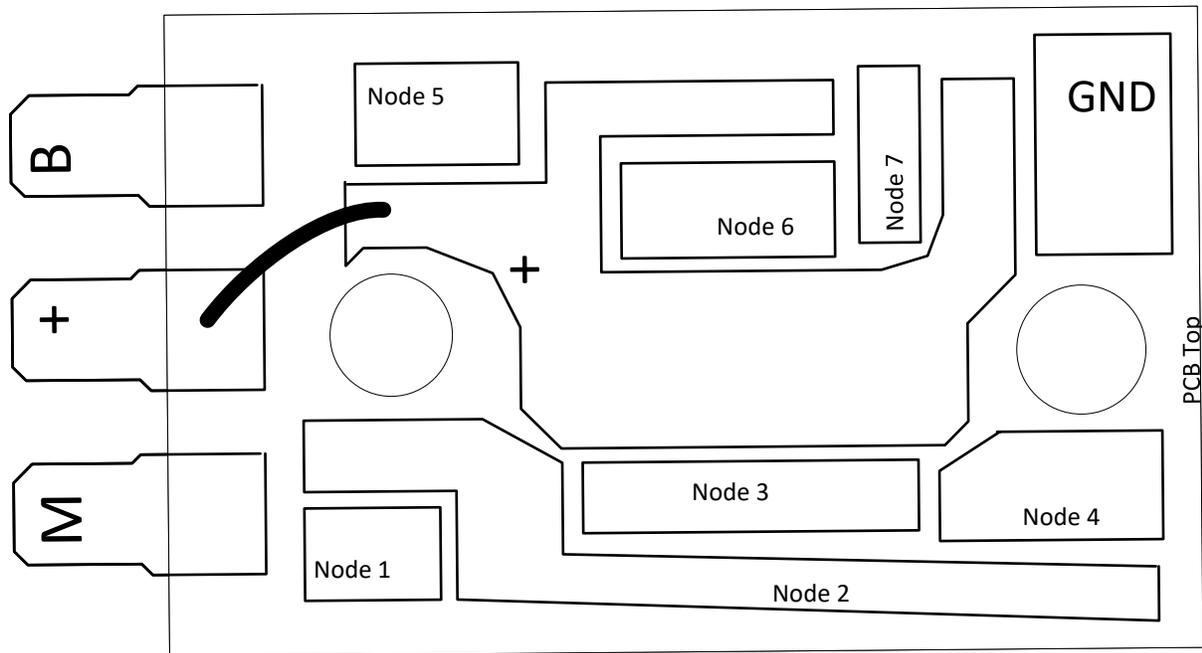
I made a sketch of the copper patterns, made a mirror image and labeled all of the circuit nodes.

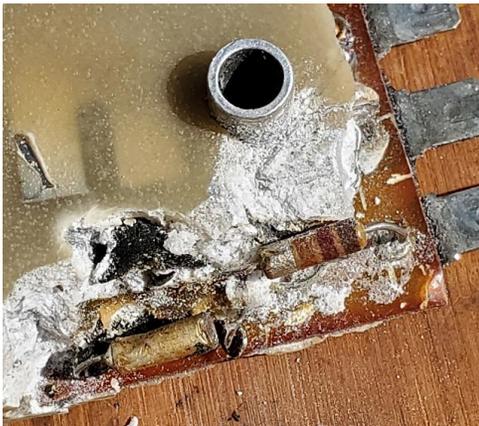
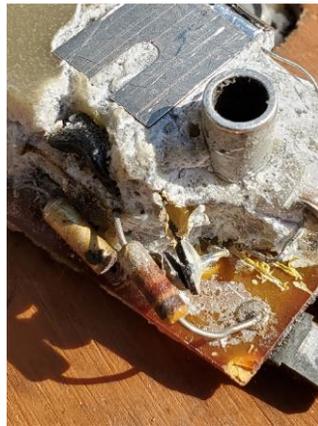
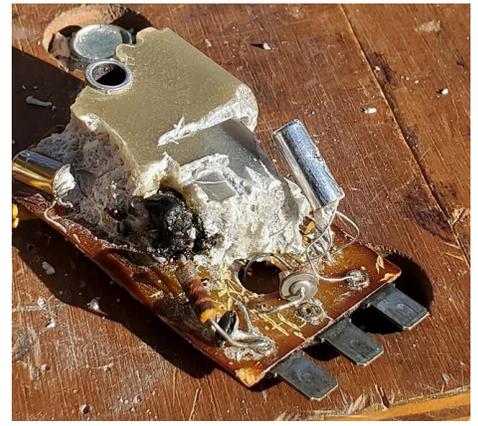
I then moved to the top of the PCBA and started removing the epoxy. Unfortunately, the heat required to remove the epoxy was hotter than the melting point of the capacitors' plastic packaging. As a result, the capacitance of each is unknown.

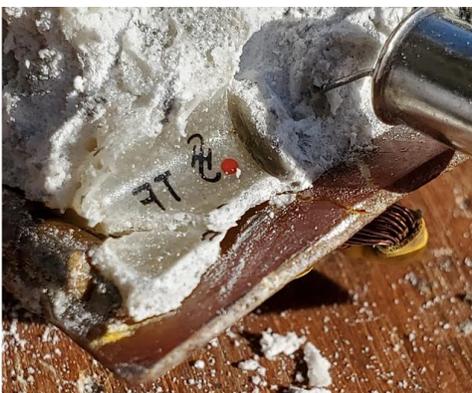
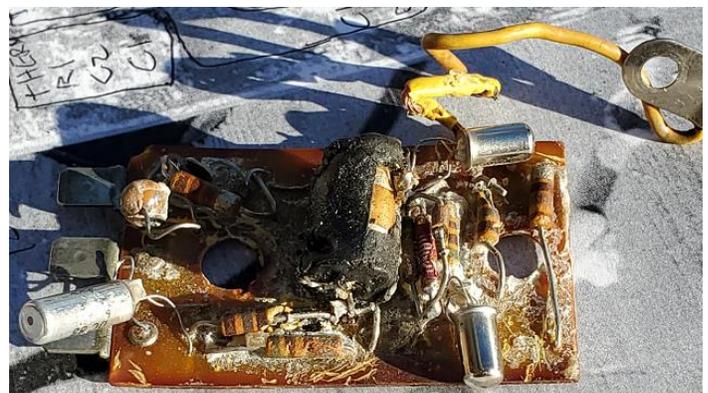
Removing the epoxy from two of the transistors also removed their markings, although part of the markings of one of them remained inside of part of the epoxy which helped us to figure out which transistor was likely used. The output transistor was protected by a heat sink, so we could read that it was a Mullard OC83. Fortunately, the Zener diode survived, but the regular diode broke during the epoxy removal process. The epoxy made it difficult to read the colors of the resistors and some of the resistors broke during the remaining epoxy removal. I switched to a heat pencil in the middle of the project, which lessened the collateral damage to the components.

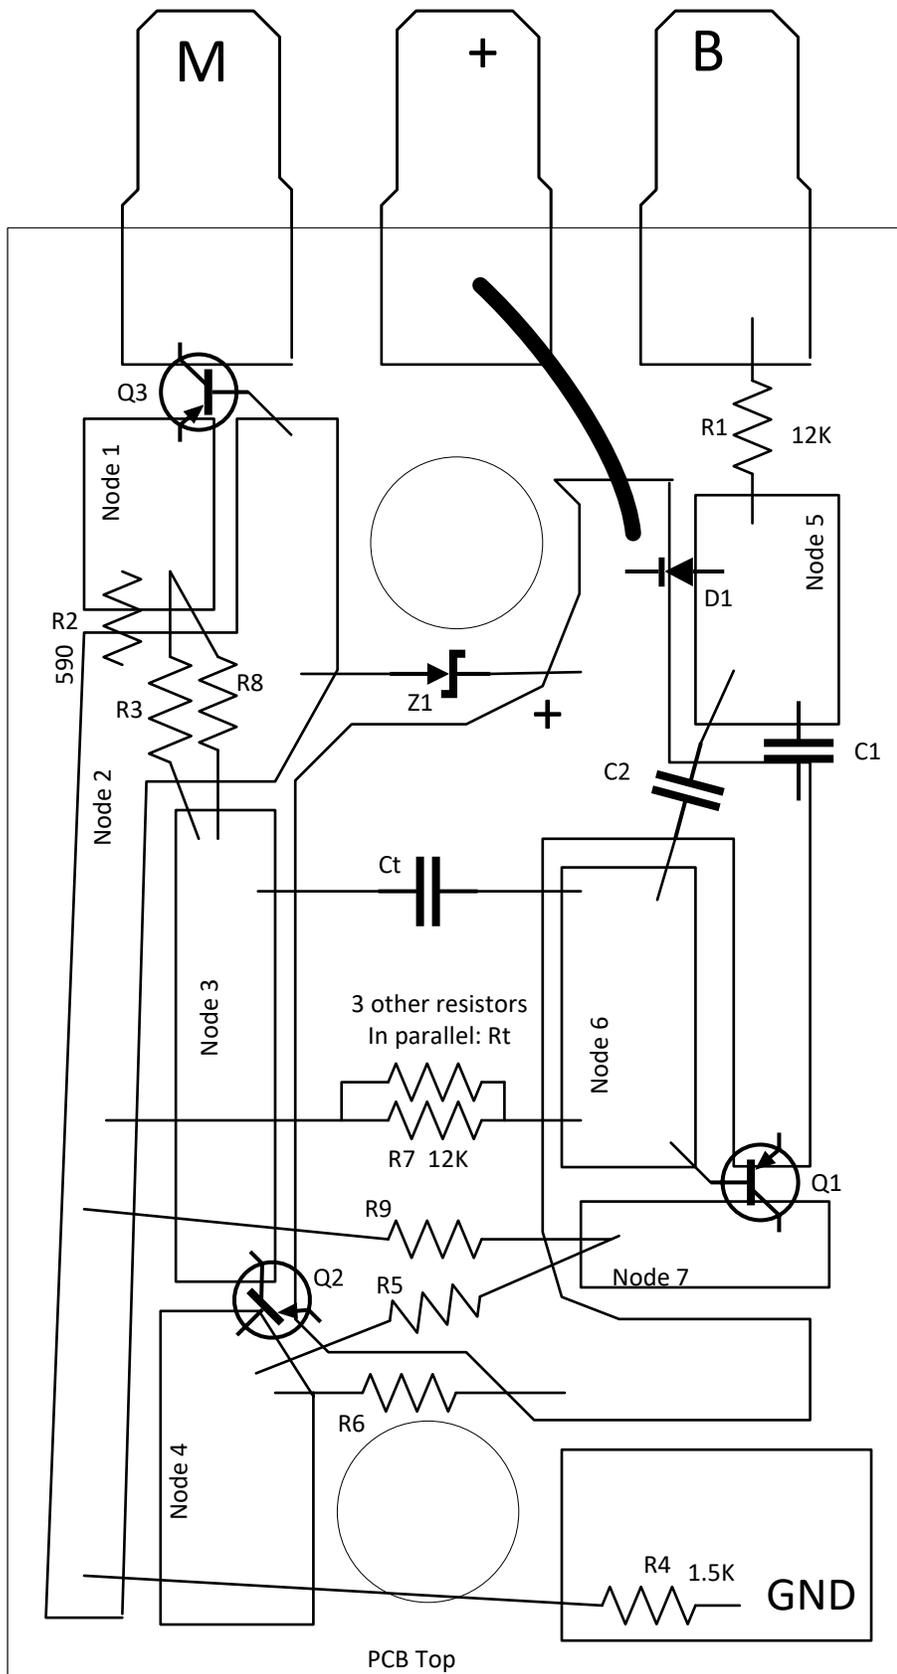
As I removed epoxy from around the components, I mapped them to the nodes they were connected to.

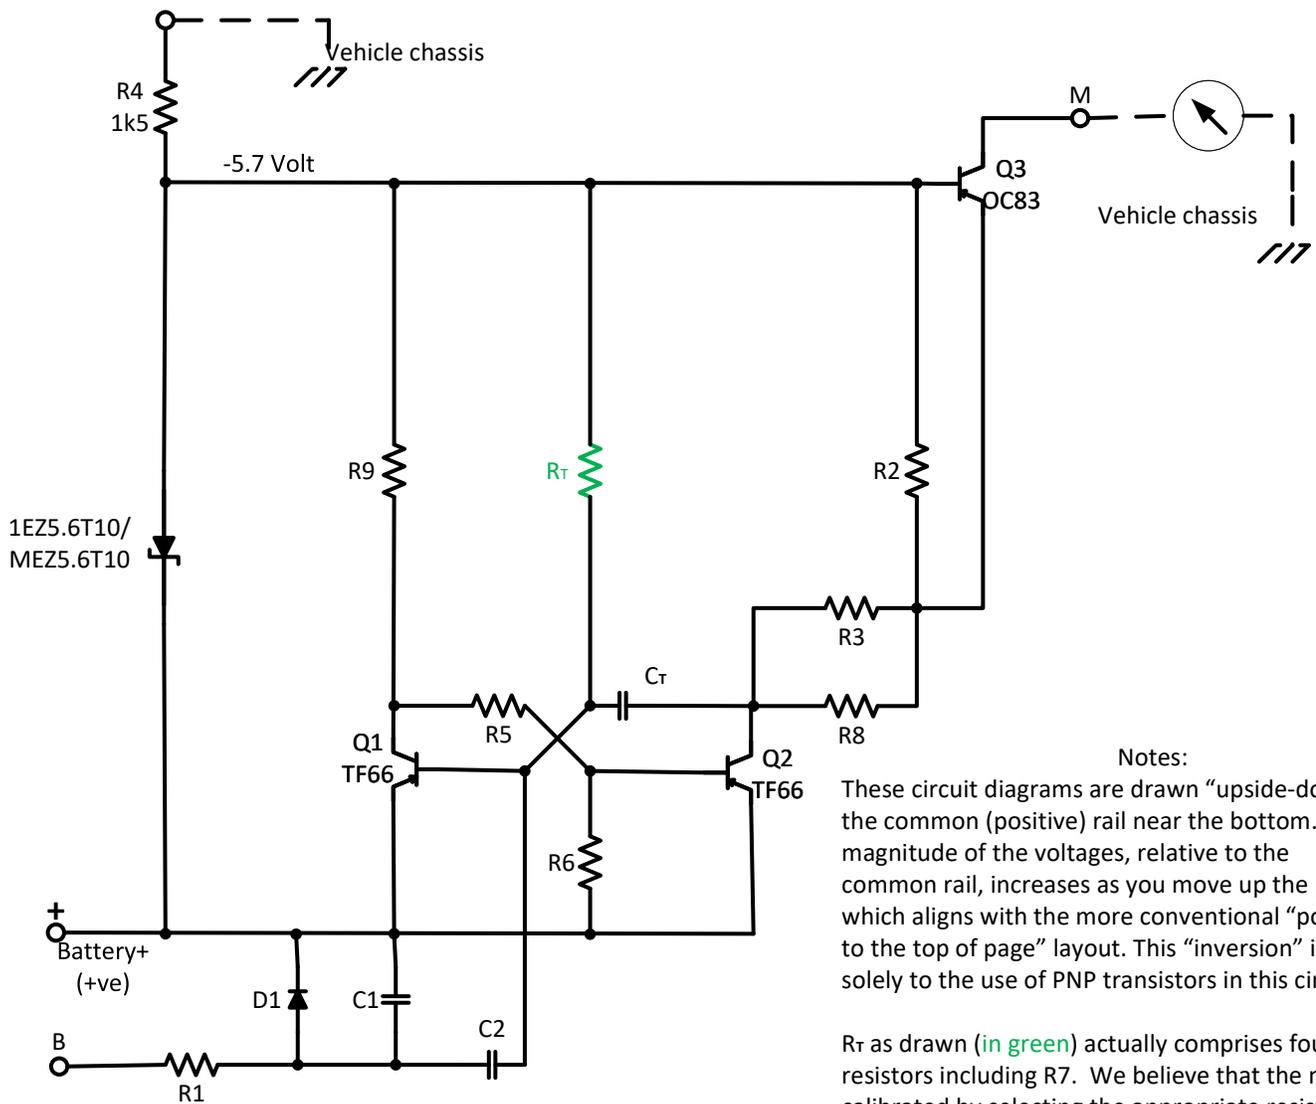
I worked very closely with Alex Miller who developed these schematics for the remote module. His insight and knowledge was crucial to figuring out the circuit. Where the component part numbers and values were not determined, he was able to infer what they probably were from the similarities to the Smiths Gen 1 circuit design.

These circuit diagrams are drawn “upside-down” with the common (positive) rail near the bottom. The magnitude of the voltages, relative to the common rail, increases as you move up the page which aligns with the more conventional “positive to the top of page” layout. This “inversion” is due solely to the use of PNP transistors in this circuit.

R_T as drawn (in green) actually comprises four parallel resistors including R7. We believe that the module is calibrated by selecting the appropriate resistors for R_T.

- R1 = 12k – (Measured and color bands)
- R2 = 510 – (Measured and color bands)
- R3 = 180 –(Color bands and back-calculation of circuit values)
- R4 = 1k5 – (Measured)
- R5 = 510 – (Measured and color bands)
- R6 = 180 – (color bands)
- R_T = compound calibration resistance – varies between units
- R8 = 560 – (Measured & rounded to nearest E12 value)
- R9 = 1.2k – (Measured & rounded to nearest E12 value)
- C1 = Unknown
- C2 = Unknown
- C_T = 0.22uF? – (plausible? - assumed from Gen-1 circuit)
- D1 = 2E4 ? – (Most probable type from databooks)
- Z1 = 1EZ5.6T10 – (Most probable type from measured Volts and databooks)
- Q1 = TF66 – (plausible? Based on markings left in epoxy)
- Q2 = TF66 – assumed same as Q1
- Q3 = OC83 – Read from transistor case (protected from epoxy by heat sink)

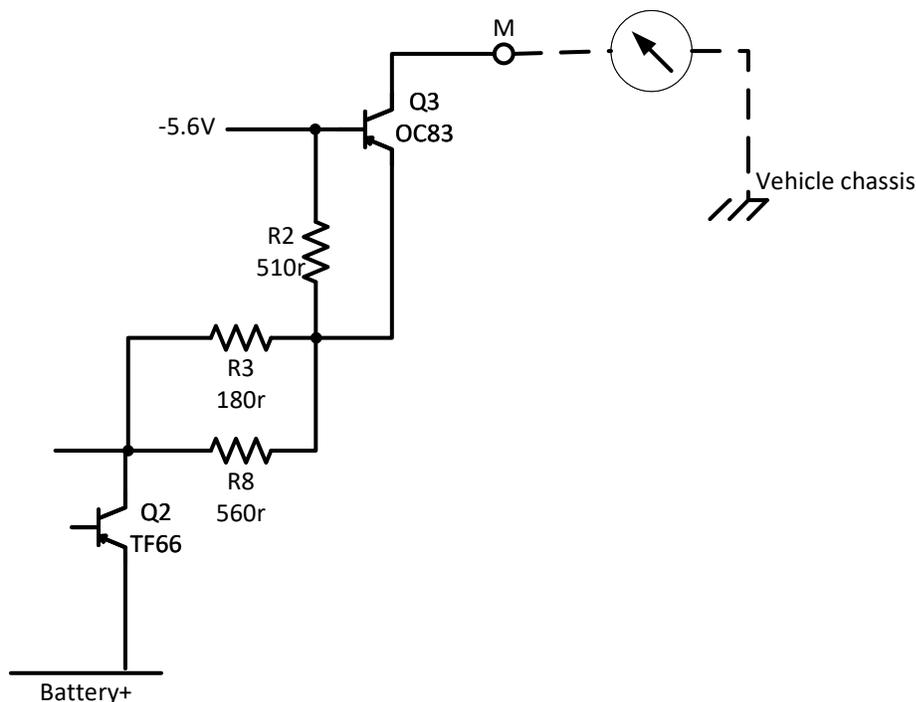
VOLVO GEN-0.5 OUTPUT STAGE CIRCUIT DIAGRAM

TF66, $V_{CEsat} = 0.5V$ from databook
 OC83 $V_{be} = 120mV @ 30C$ – from databook
 The parallel resistors R3 and R8 have a combined resistance of 136 Ohms (136.2162 Ohms).
 R2 is present to limit $V_{BE max} (= -3V)$ for the OC83.
 The current of 0.235mA through R2 with Q3 ON is ignored in the following calculations.
 “||” means “in parallel with”

With Q2 OFF, no current will flow through R2, R3||R8 or Q3. Both the base and emitter of Q3 will be at -5.6V

At the instant Q2 turns ON, Q3 will also turn on as the supply voltage -0.5V is applied between Q3 base and emitter. Current will start flowing and increase to a value where 0.12V (V_{be}) exists between the base and emitter of Q3. The current at which this occurs is that which causes a voltage drop of $5.6 - 0.5 - 0.12V$ or 4.98V across R3||R8 and is equal to $4.98 / 136 = 36.6mA$. Q3 is operating in its active region and maintains 0.12V between base and emitter thus this current through R3||R8 is maintained at this value. That is, Q3 is a constant current source that is independent of load resistance. Provided only that the external voltage is sufficient to drive this current through the load. (≥ -8 Volts relative to circuit common rail.)

V_{be} will vary by about 1V over the range 20 - 60C (from datasheet). There is no temperature compensation provided and with the (assumed) Zener having a temperature coefficient of +0.03%/C, the output to the indicated rpm will increase slightly with temperature.
