Volvo P1800(S) package tray plywood templates
Original plywood had 9mm thickness
Some holes (e.g. drive-in nuts for rear bench) may be missing

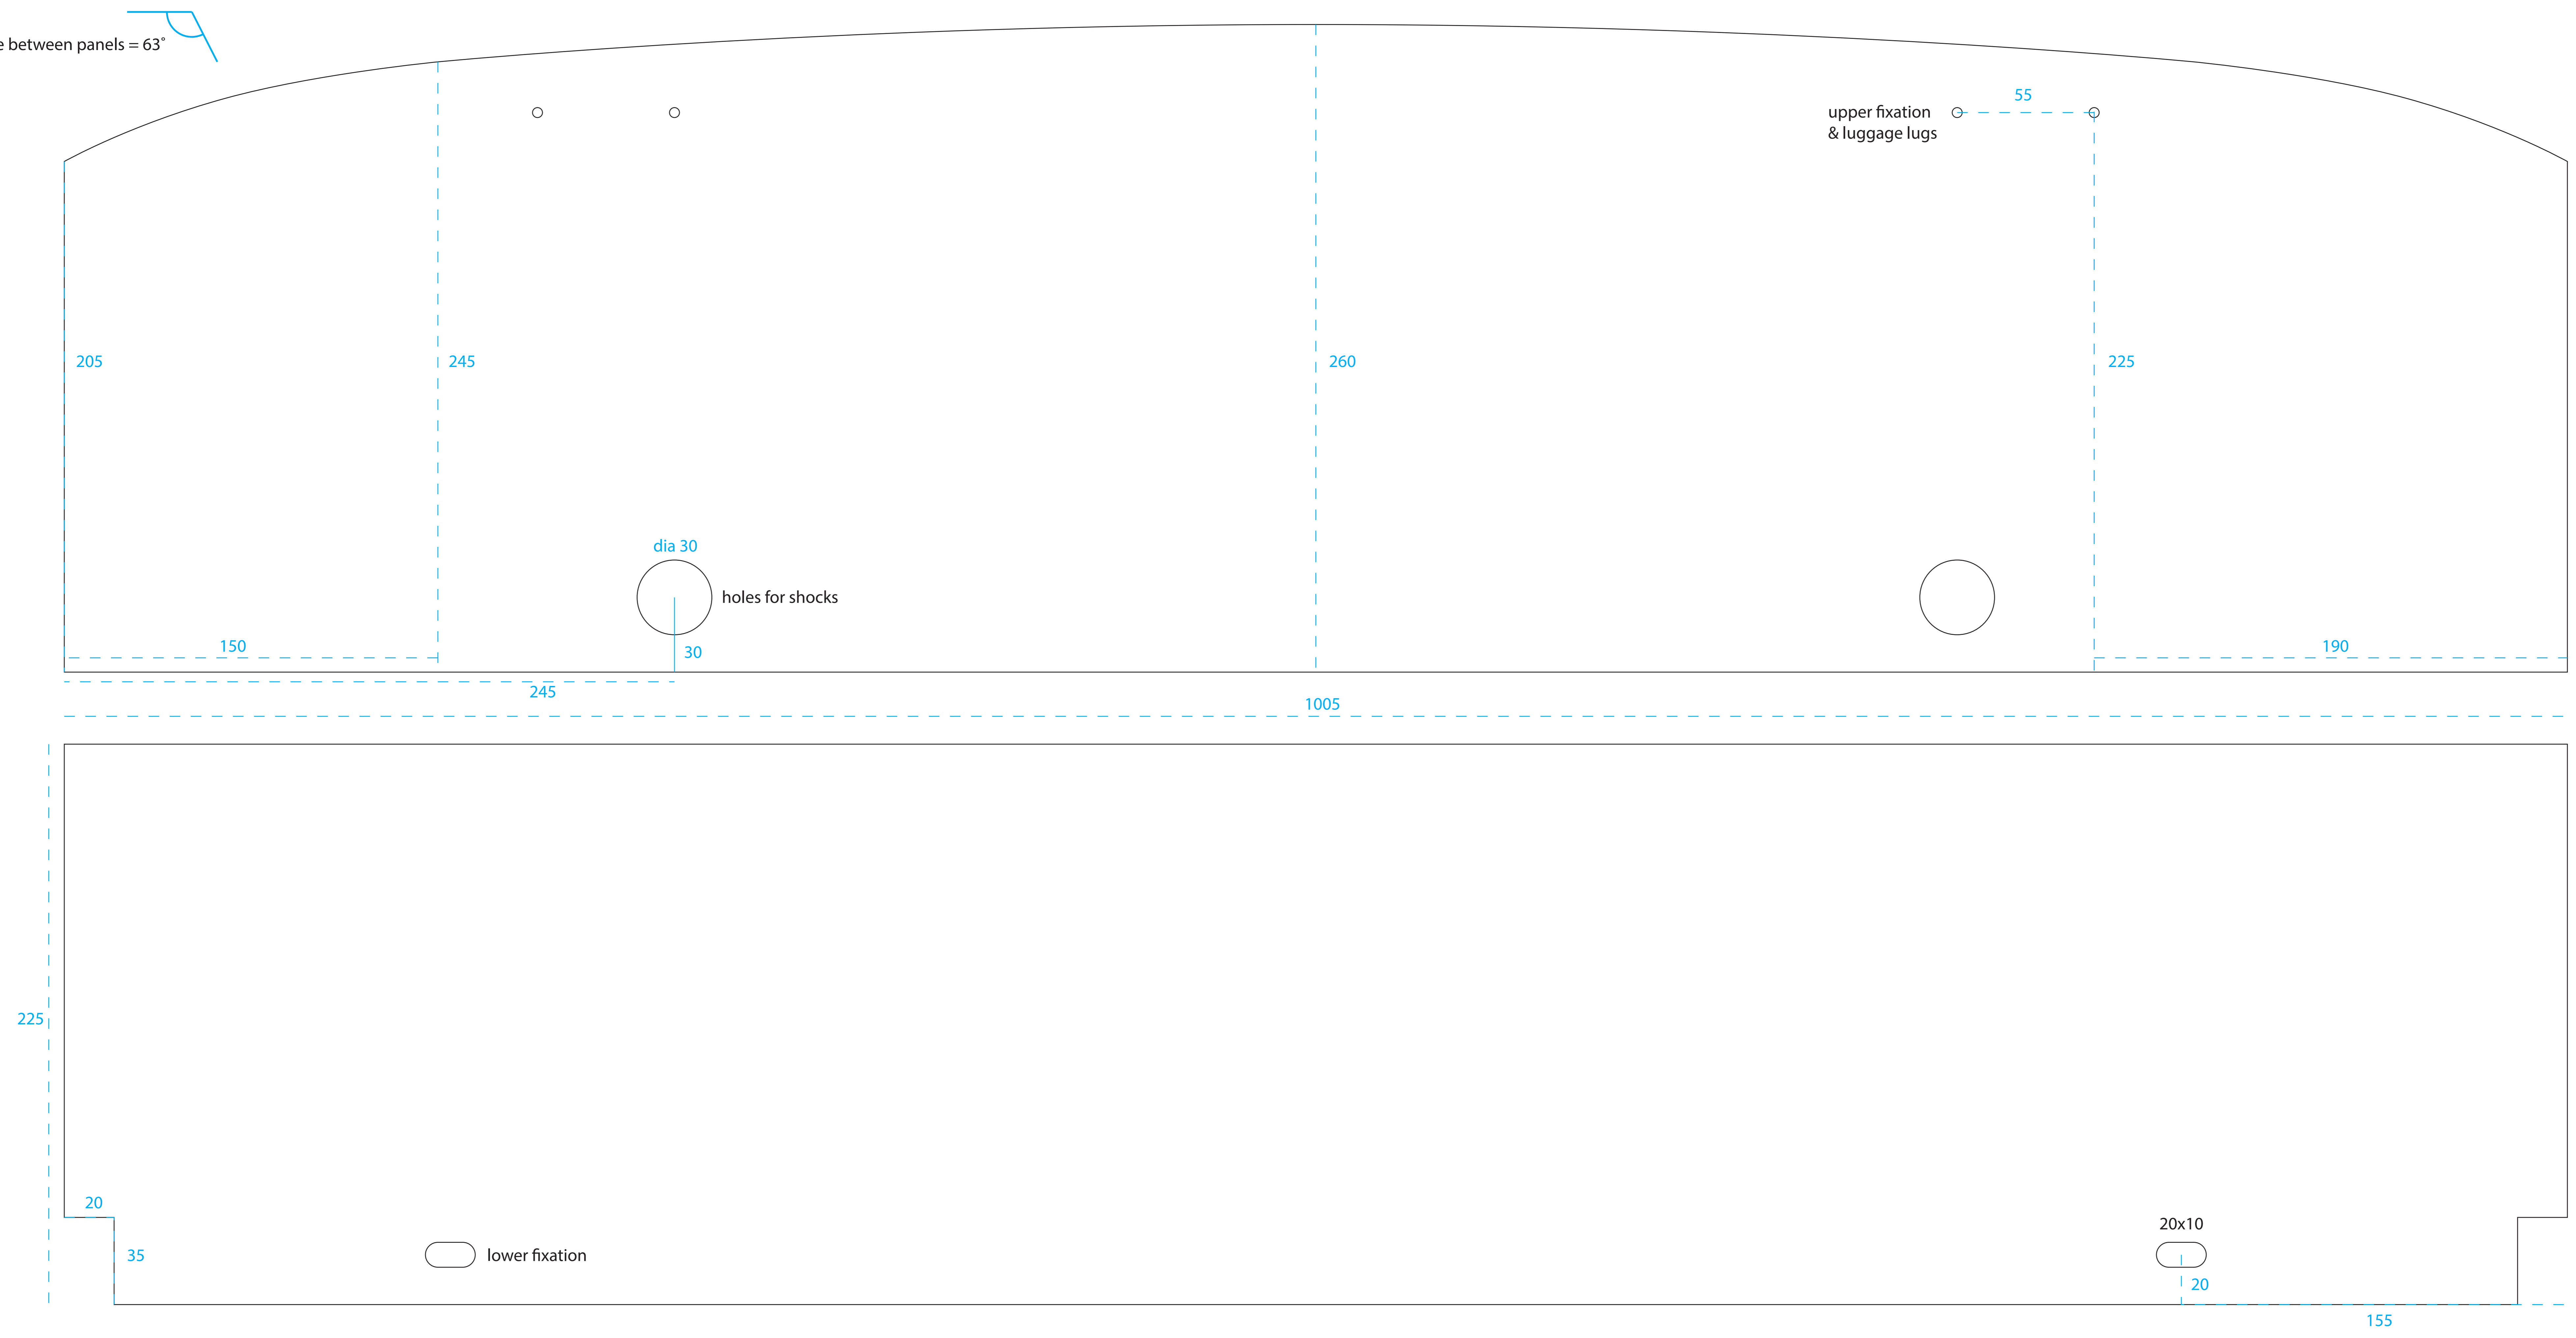
Angle between panels = 63°
